## 1 Introduction and Overview

As part of this freight cluster plan, a detailed traffic study was conducted at several key intersections within the study area. The traffic study included capacity, operational and safety analyses of these intersections to identify deficiencies and recommend potential improvement projects to mitigate the deficiencies. The following sections of this technical memorandum detail the selection of the intersections, the traffic analysis methodology and results, and description of proposed improvements.

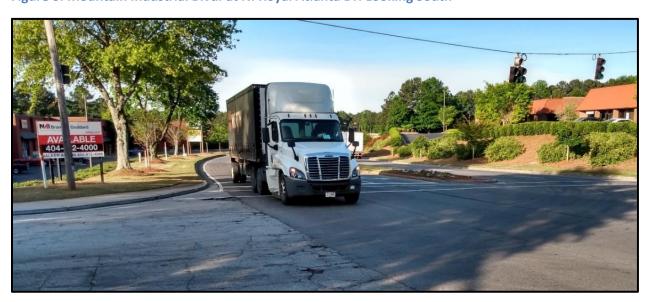
Figure 6: Mountain Industrial Blvd. at N. Royal Atlanta Dr. Looking South

- There is a horizontal curve along Mountain Industrial Blvd. at the intersection. Sight distance appears
  to be restricted for the eastbound right-turning traffic from N. Royal Atlanta Dr. to southbound
  Mountain Industrial Blvd.

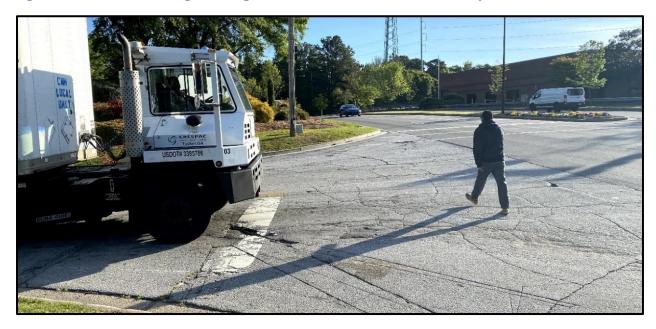
Figure 7: Pedestrian Crossing West Leg of Mountain Industrial Blvd. at N. Royal Atlanta Dr.

- Crosswalks and pedestrian signals are present across the north and south legs of the intersection. There are no pedestrian accommodations to cross N. Royal Atlanta Dr. on either side of the intersection. The intersection is also not equipped with curb ramps.

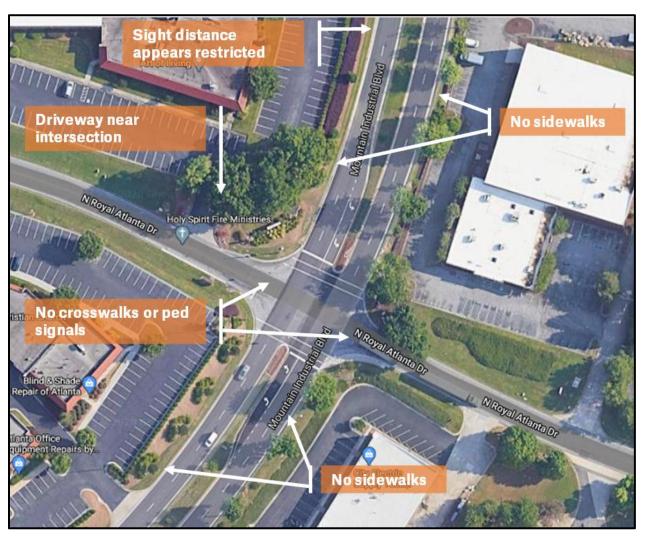
Figure 8: Intersection Operations Review on an Aerial View

- The curb ramp on the northeast corner is in poor condition due to encroachment by westbound right-turning vehicles from N. Royal Atlanta Dr. to northbound Lawrenceville Hwy. (US 29/SR 8).

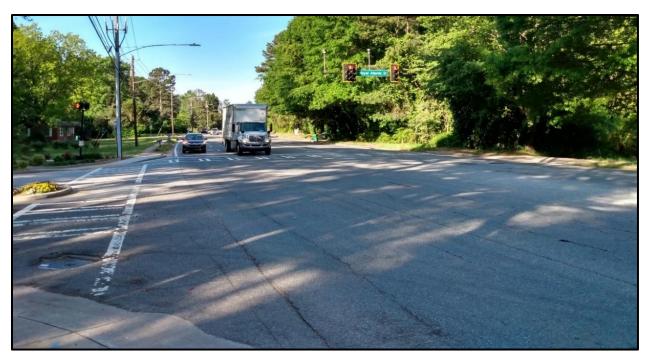
Figure 9: Lawrenceville Hwy. (US 29/SR 8) at N. Royal Atlanta Dr. Looking South

- Overgrown vegetation along Lawrenceville Hwy. (US 29/SR 8) to the immediate west of the intersection obscures signal heads and pedestrian crossing signals.

- The westbound N. Royal Atlanta Dr. approach has a short and narrow dedicated right-turn lane. The right-turn lane striping is barely visible.
- There are several residential driveways in close proximity to the intersection.

- Repave and restripe N. Royal Atlanta Dr. at the intersection, and install raised pavement markers.
   Raised pavement markers improve the intersection safety by enhancing delineation and driver awareness and by providing positive guidance for motorists, especially in low visibility conditions.
- Install median nose delineators at the median along N. Royal Atlanta Dr.

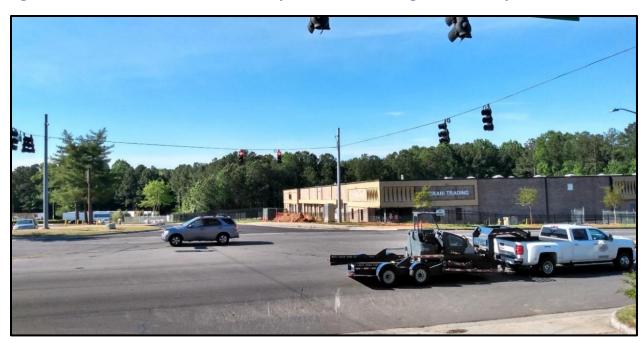
Figure 11: Mountain Industrial Blvd. at S. Royal Atlanta Dr. Looking towards S. Royal Atlanta Dr.

- Mountain Industrial Blvd. runs east-west at this intersection. The north leg of this intersection is a
  steep uphill driveway to a public storage facility. There is a horizontal curve along the east leg of
  Mountain Industrial Blvd. approaching the intersection where the sight distance appears to be
  restricted for vehicles exiting the public storage driveway. There is a supplemental signal head at the
  intersection for vehicles along Mountain Industrial Blvd. approaching the intersection from the east.
- There are no pedestrian accommodations at this intersection. The short section of concrete that exists at the southwest quadrant of the intersection does not serve the pedestrian community but instead exists to eliminate the "rutting of the shoulders" from trucks tracking over the curb and the roadway shoulder due to inadequate turning radii.

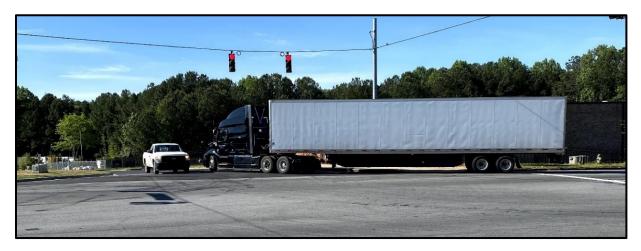
Figure 12: Truck Turning Right onto S. Royal Atlanta Dr.

- Eastbound right-turning trucks from Mountain Industrial Blvd. to southbound S. Royal Atlanta Dr. were observed tracking over the southwest curb and also encroaching onto the northbound approach lane on S. Royal Atlanta Dr. Similarly, northbound right turning trucks from S. Royal Atlanta Dr. to eastbound Mountain Industrial Blvd. were also observed tracking over the curb on the southeast quadrant. These intersection curb radii appear to be designed based on older design standards and design vehicles with shorter wheel bases and doesn't appear to be able to accommodate the newer trucks on the roadways currently with longer wheel bases.

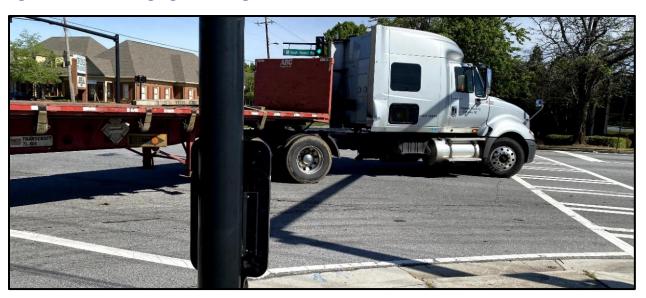
Figure 14: Truck Turning Right onto Hugh Howell Rd. from Northbound Tucker Industrial Rd.

- Northbound trucks from Tucker Industrial Rd. turning right onto eastbound Hugh Howell Rd. (SR 236)
   frequently encroach onto the westbound lanes on Hugh Howell Rd. (SR 236).
- Curb ramps and crosswalks are present on all four corners, but sidewalks are present only along the southeast quadrant of the intersection.
- There is an existing MARTA bus route along Hugh Howell Rd. (SR 236) at this intersection.
- There are several closely spaced driveways along the south side of Hugh Howell Rd. (SR 236) near the intersection.

- Install backplates with retroreflective borders to all traffic signal head indications.
- Install flashing yellow arrow signal head indications for the left-turns on all four approaches.

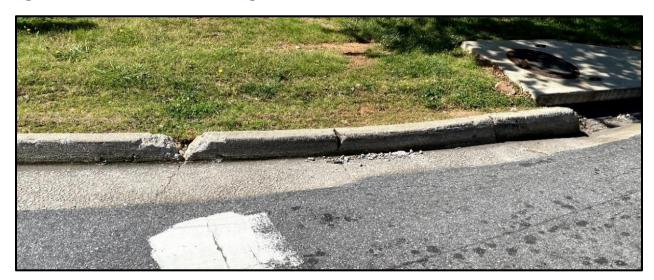
Figure 18: Curb and Storm Drain Damage at the Southwest Corner of the Intersection

- Curb and storm drain damage are present on the southwest quadrant of the intersection. This
  intersection curb radii appears to be designed based on older design standards and design vehicles
  with shorter wheel bases and doesn't appear to be able to accommodate the newer trucks on the
  roadways currently with longer wheel bases.

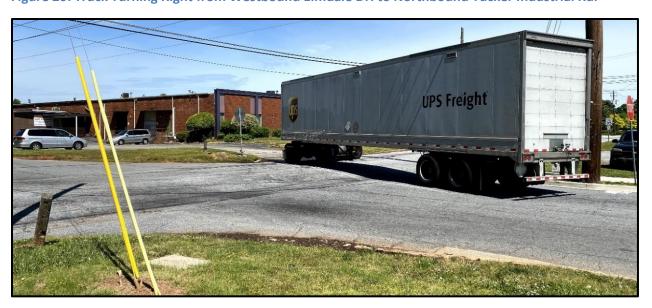
Figure 20: Truck Turning Right from Westbound Elmdale Dr. to Northbound Tucker Industrial Rd.

- There is sidewalk along the north side of Elmdale Dr. east of the intersection, and there is a curb ramp on the northeast quadrant of the intersection. No crosswalks exist at this intersection.
- Curbs are deteriorated at all corners of the intersection likely from over tracking of cars and trucks.
- There is moderate amount of truck turning movements at the all-way stop controlled intersection.

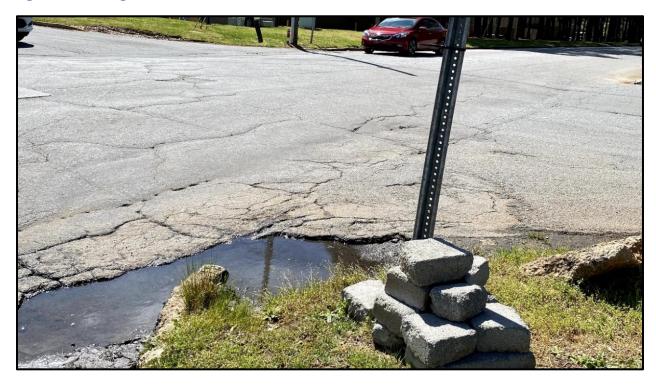
Figure 21: Drainage Issues at Tucker Industrial Rd. and Elmdale Rd.

• The pavement is in poor condition with potholes and pooled water due to the lack of positive drainage and inadequate storm water infrastructure.

- Repave and restripe the intersection, and install raised pavement markers. Raised pavement markers improve the intersection safety by enhancing delineation and driver awareness and by providing positive guidance for motorists, especially in low visibility conditions.
- Install raised curb and gutter on all four corners of the intersection with wide curb radii to
  accommodate right-turn movements by trucks. Install drainage structures at the intersection to
  ensure positive drainage at the intersection and along all four approaches.

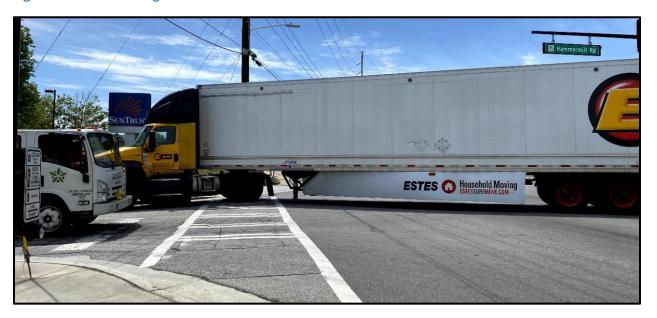
Figure 24: Truck Turning Left from Southbound Mountain Industrial Blvd. onto Hammermill Rd.

- Pedestrian accommodations including crosswalks, pedestrian signals and curb ramps are present on all four corners of the intersection. There are no sidewalks along the west side of Mountain Industrial Blvd. south of the intersection.
- There is an existing MARTA bus route along Mountain Industrial Blvd. at this intersection.
- Trucks turning right from northbound Mountain Industrial Blvd. to eastbound Hammermill Rd. were
  observed to have difficulty in maneuvering the southeast corner of the intersection due to the lack of
  a northbound right turn lane and narrow receiving lane on Hammermill Rd.

- Install backplates with retroreflective borders to all traffic signal head indications.
- Install flashing yellow arrow signal head indications for the left-turns on the southbound Mountain Industrial Blvd. approach and the westbound Hammermill Rd. (South) approach.
- Install a single right-turn lane with channelization and wide curb radius accommodating truck turning movements along the northbound Mountain Industrial Blvd. approach. (This is in addition to the improvements recommended by the TSCID's December 2019 traffic engineering study.)

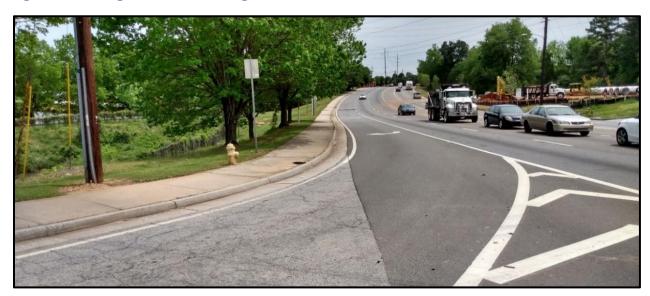
Figure 27: Looking South from East Leg of Intersection of Mountain Industrial Blvd. at Greer Cir.

- Pedestrian accommodations, including crosswalks, pedestrian signals and curb ramps, are present on all four corners of the intersection. There are no sidewalks along the west side of Mountain Industrial Blvd. south of the intersection or along Greer Cir. west of the intersection.
- There are existing MARTA bus routes along both Mountain Industrial Blvd. and Greer Cir. at this intersection.
- This intersection is oriented at a skewed angle, which causes southbound right-turning trucks from Mountain Industrial Blvd. to track over the curb and also to encroach onto the eastbound approach lanes on Greer Circle. This intersection curb radii appears to be designed based on older design standards and design vehicles with shorter wheel bases and doesn't appear to be able to

- accommodate the newer trucks on the roadways currently with longer wheel bases. The intersection skew does not appear to restrict sight distance along Mountain Industrial Blvd.
- The pavement is in good condition on all legs except the east leg of Greer Cir., which is showing some signs of distress but is in fair condition overall.

- Repave and restripe Greer Cir. east of the intersection, and install raised pavement markers.
   Raised pavement markers improve the intersection safety by enhancing delineation and driver awareness and by providing positive guidance for motorists, especially in low visibility conditions.
- Install protected/permissive phasing for the eastbound Greer Cir. left-turn movement.
- Install backplates with retroreflective borders to all traffic signal head indications.
- Install flashing yellow arrow signal head indications for the left-turns on all four approaches.

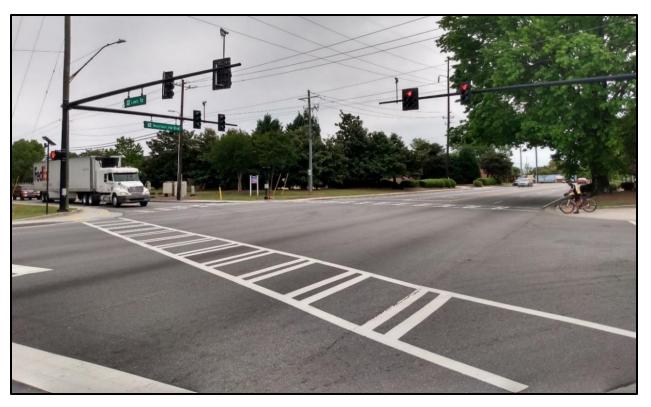
Figure 29: Trucks and Bicyclists Observed at Mountain Industrial Blvd. at Lewis Rd.

- Pedestrian accommodations, including crosswalks, pedestrian signals and curb ramps, are present on all four corners of the intersection. There are no sidewalks along the west side of Mountain Industrial Blvd. south of the intersection or along Lewis Rd. west of the intersection.
- There is an existing MARTA bus route along Mountain Industrial Blvd. at this intersection.
- Right-turning trucks were observed to have difficulty maneuvering the intersection at all four quadrants of the intersection.
- Multiple bicyclists were observed using Lewis Rd. at this intersection.
- There is a driveway very close to the intersection along Lewis Rd. west of the intersection.

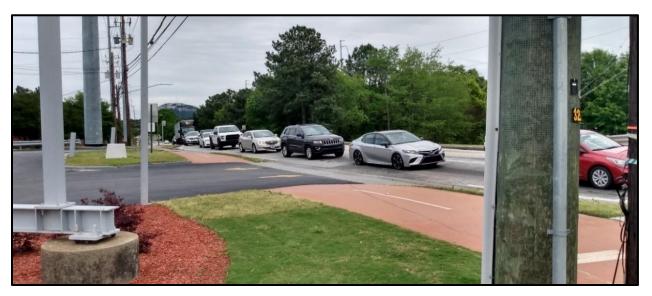
Figure 32: Traffic Queuing on E. Ponce de Leon Ave. (East Leg of Intersection)

- Queuing was observed on E. Ponce de Leon Ave. in both directions during the afternoon peak, and not all traffic could make it through the signal in one cycle.
- There are driveways very close to the intersection at the northeast corner of the intersection associated with the Texaco gas station.
- Pedestrian accommodations, including crosswalks, pedestrian signals and curb ramps, are present on all four corners of the intersection. There are sidewalks along both sides of Mountain Industrial Blvd./N. Hairston Rd. Stone Mountain Trail is located along the north side of E. Ponce de Leon Avenue. A short section of sidewalk exists on the south west corner of E. Ponce de Leon Ave. at Mountain Industrial Blvd. that ends at a MARTA bus stop.

- There are existing MARTA bus routes along both Mountain Industrial Blvd. and E. Ponce de Leon Ave. at this intersection.
- The bus stop on the northwest corner has a dedicated pull-out and large bus shelter, serving MARTA Bus Route 121.
- There is a damaged guardrail at the southeast corner of the intersection.
- The NE, SE and SW corners of the intersection do not meet the min. design truck turning radius of 45 ft. for the typical truck type in the district which is a WB-50.

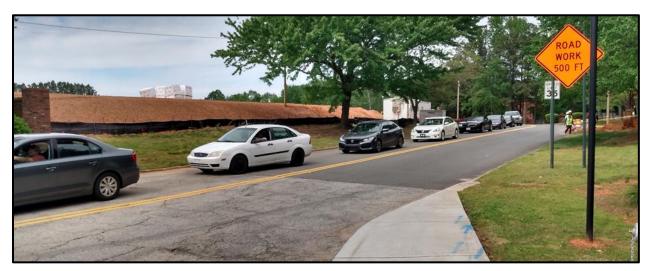
Figure 35: Traffic Queuing on Rock Mountain Blvd. (North Leg of Intersection)

- There is a horizontal curve along the Rock Mountain Blvd. approach.
- Queuing was observed on the southbound Rock Mountain Blvd. approach.
- Stone Mountain Trail is located along the north side of E. Ponce de Leon Ave. Pedestrian accommodations, including a marked crosswalk, pedestrian signals and curb ramps, are present along the north side of E. Ponce de Leon Ave. The marked crosswalk is fairly worn and faded.
- There are no sidewalks along the south side of E. Ponce de Leon Ave. There are no crosswalks to cross E. Ponce de Leon Ave. at the intersection.

- There is an existing MARTA bus route along E. Ponce de Leon Ave. at this intersection, and there is a MARTA bus stop shelter on the north side of E. Ponce de Leon Ave.
- Pepisco semi-trailer intermediate (WB 40) and semi-tractor combination (WB 50) trucks are the
  prevalent truck types at this intersection. Pepisco trucks enter Rock Mountain Blvd. from the east and
  due to the deficient radii track across the catch basin, C&G and storm line infrastructure. This has
  resulted in a long history of repetitive damage and subsequent repairs at the northeast corner of the
  intersection.

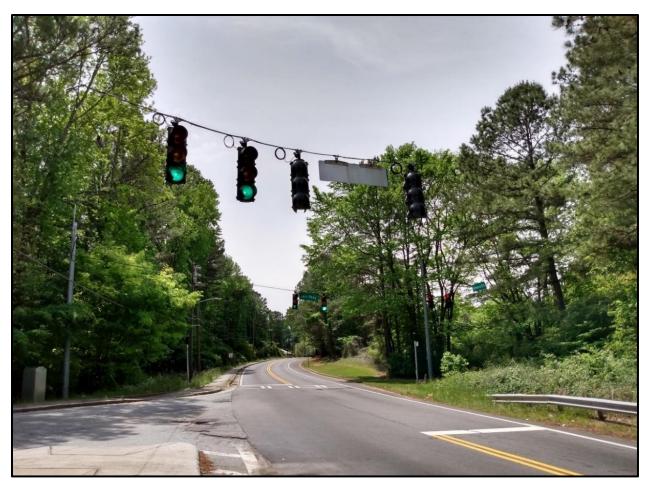
- Sight distance appears to be restricted on the north leg of the intersection due to a horizontal curve and the bridge over Stone Mountain Freeway (US 78). There are supplemental signals at the intersection to aid motorists approaching the intersection from the north.

- The intersection has a skewed angle, which makes it difficult for commercial vehicles and buses to maneuver turns without intruding in other travel lanes. Both the southbound left turn from Idlewood Rd. to eastbound Sarr Pkwy. and the westbound channelized right turn from Sarr Pkwy. to northbound Idlewood Rd. were observed to be difficult maneuvers for MARTA buses.

- There are worn pavement markings at this intersection on Sarr Parkway as well as a large pothole on Sarr Parkway.
- Debris, including several hubcaps and broken guardrails, and damaged curbs were observed, particularly at the northeast corner of the intersection. This intersection curb radii appears to be designed based on older design standards and design vehicles with shorter wheel bases and doesn't appear to be able to accommodate the newer trucks on the roadways currently with longer wheel bases.

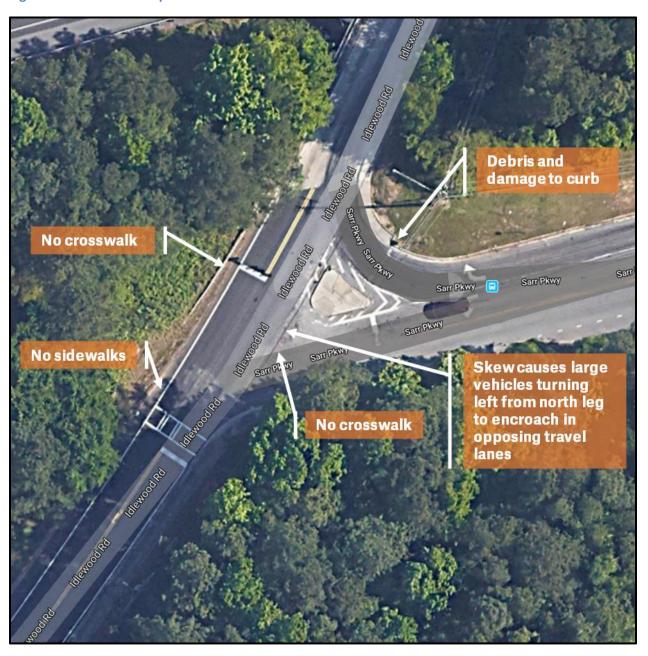
Figure 38: Intersection Operations Review on an Aerial View

- Pedestrian accommodations, including a marked crosswalk, pedestrian signals and curb ramps, are
  present to cross Idlewood Rd. south of the intersection. However, there are no sidewalks on the west
  side of Idlewood Road. There are no pedestrian accommodations across the other legs of the
  intersection.
- There is an existing MARTA bus route along the north leg of Idlewood Rd. and Sarr Pkwy. at this intersection.

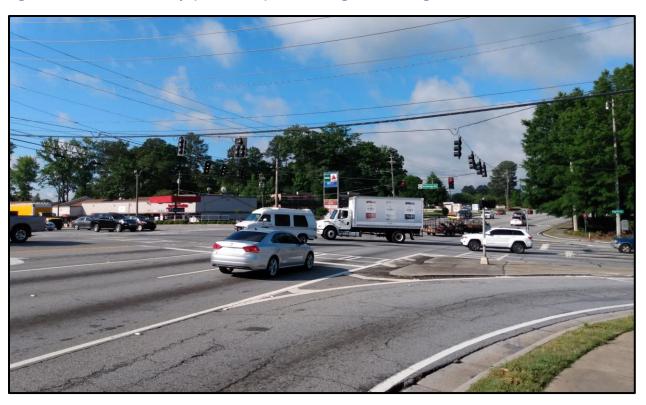
Figure 39: Lawrenceville Hwy. (US 29/SR 8) at Rockbridge Rd. Looking West from the NE Corner

- There is a vertical curve along the south leg (Rockbridge Rd.) approaching the intersection where the sight distance appears to be restricted along Rockbridge Rd. both in the northbound and southbound approaches.
- Crosswalks and pedestrian signals are present across all legs of the intersection.
- The intersection has faded pavement markings on all legs with crosswalks and stop bars especially in poor condition.
- Commercial driveways within 50 yards on both sides of all legs of the intersection.
- Minor curb damage along the southeast corner of the intersection
